Technical Report CHL-99-7  
April 1999

# **Dam Safety Assurance Model Study of Tygart Dam, Tygart River, Grafton, West Virginia**

U.S. Army Corps of Engineers  
Waterways Experiment Station  
3909 Halls Ferry Road  
Vicksburg, MS 39180-6199

Prepared for U.S. Army Engineer District, Pittsburgh  
Pittsburgh, PA 15222-4186

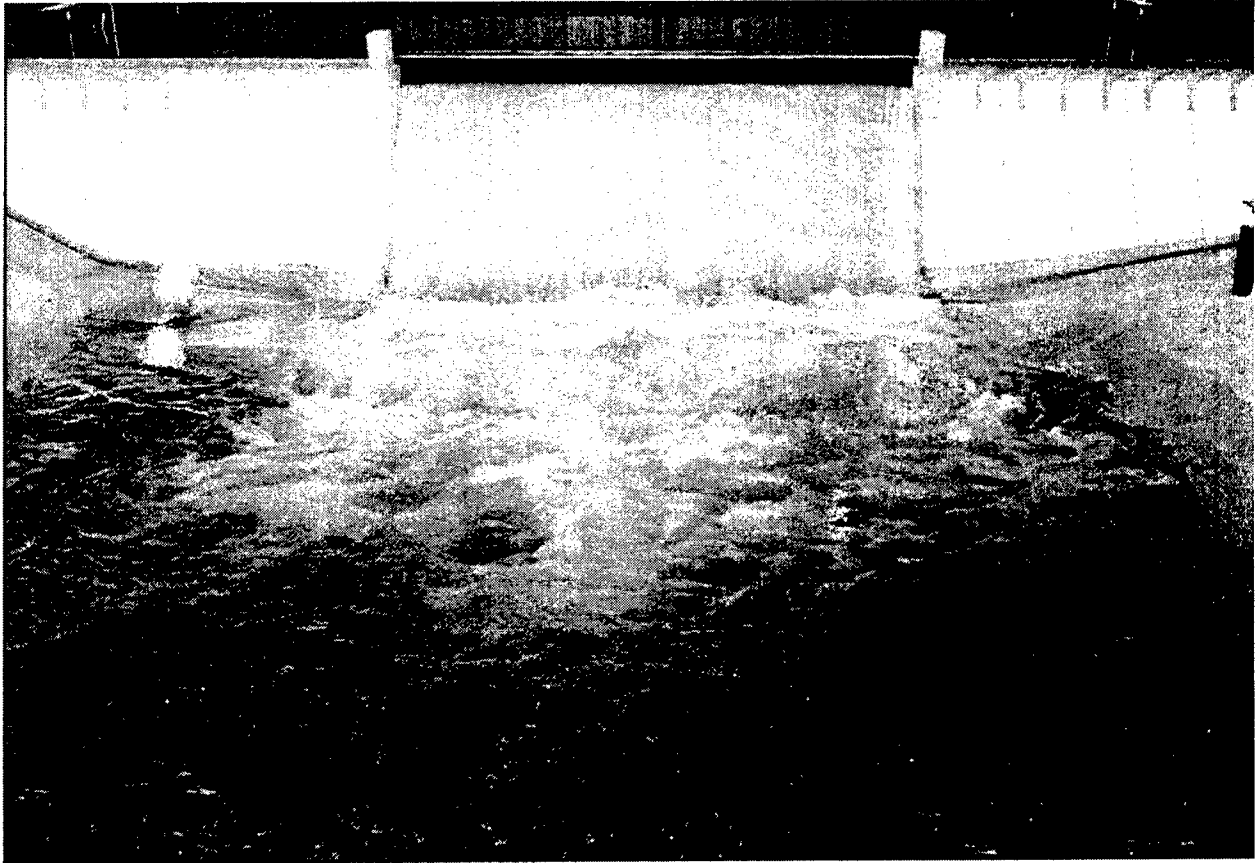
Figure 10. Type 4 design, PMF flow ( $Q = 373,120$  cfs; Pool = el 1196.95; TW el = 1031.5)

With both gutter channels installed, the Tygart Dam and spillway were able to satisfactorily pass the PMF. The overall PMF conditions are shown in Figure 10. Velocities in the downstream channel were recorded to examine

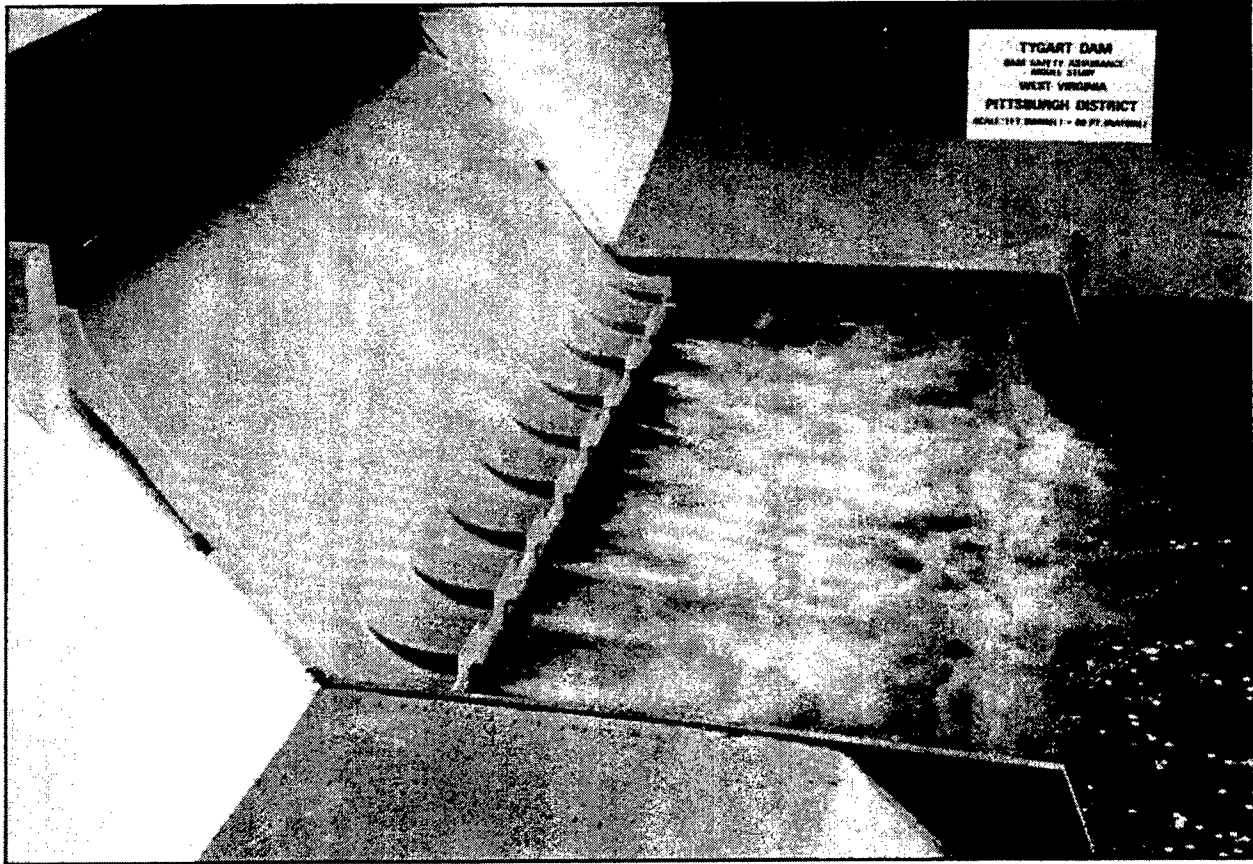
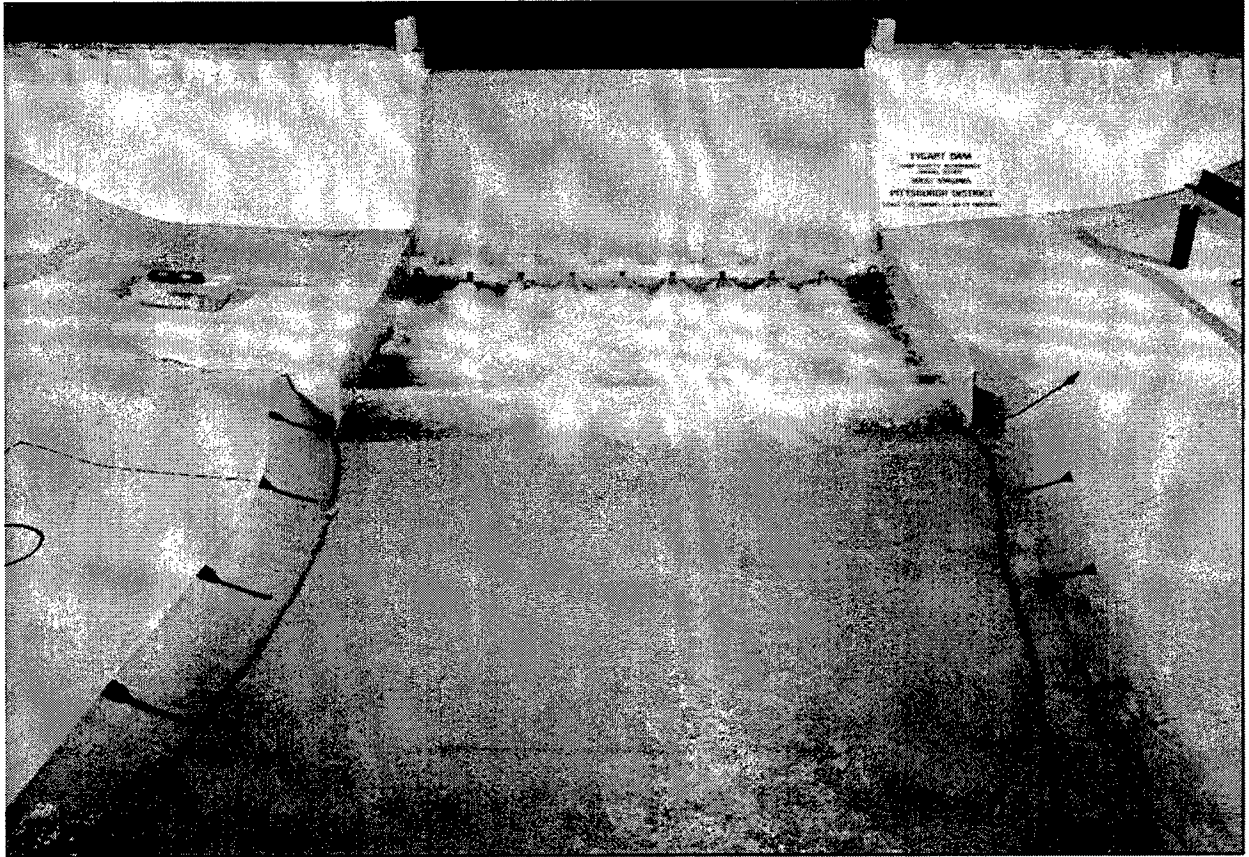
Photo 4. Tygart stilling basin flow conditions, sluice flow only ( $Q = 41,580$  cfs; Pool = el 1167.0; TW el = 987.0)

Photo 5. Tygart stilling basin flow conditions, sluice flow only ( $Q = 41,580$  cfs; Pool = el 1167.0; TW el = 987.0)

Condition A flow is shown in Photos 4-5 and represents flow from the rectangular conduits with the upstream pool at the crest el of 1167. These photos show the spreading of the conduit jet caused by the deflectors. The flow in the downstream channel has a tailwater el of 987, and this discharge is confined within the channel banks.

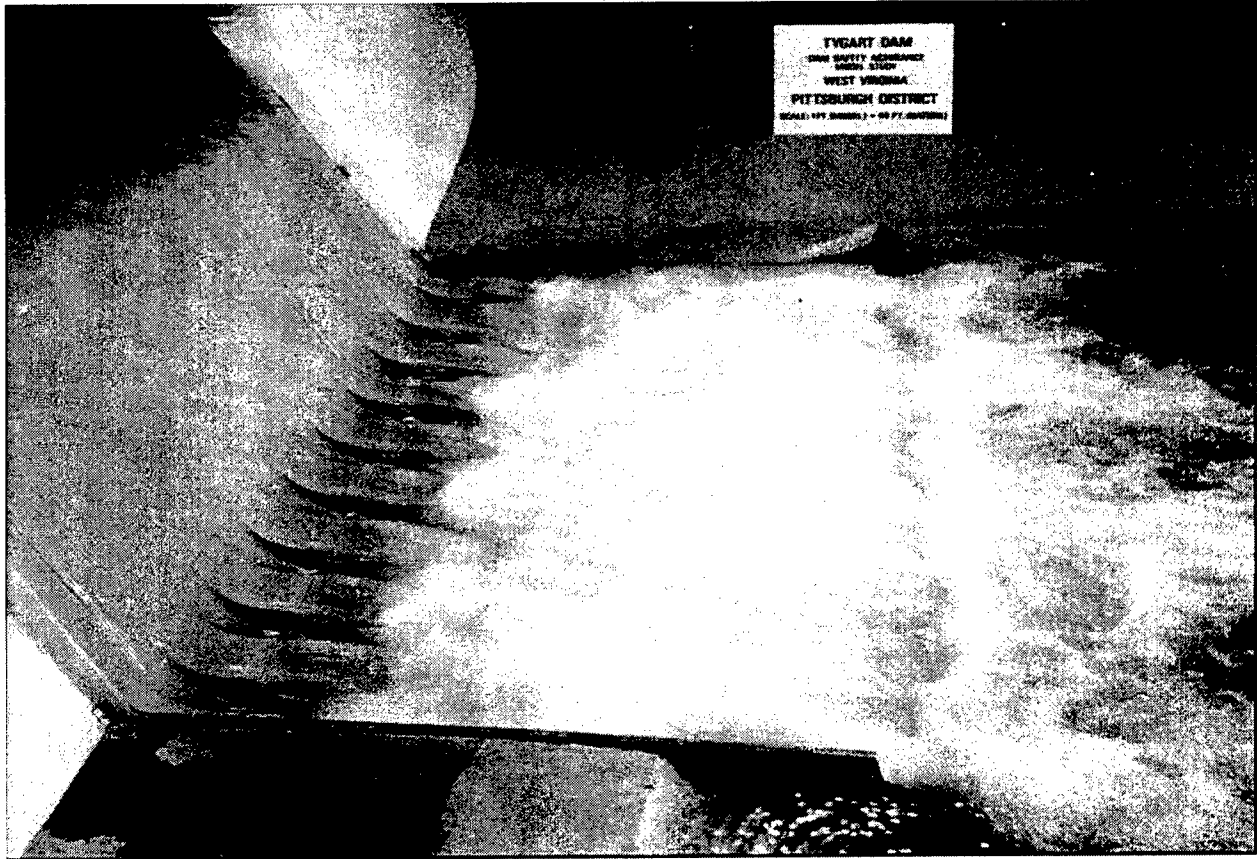
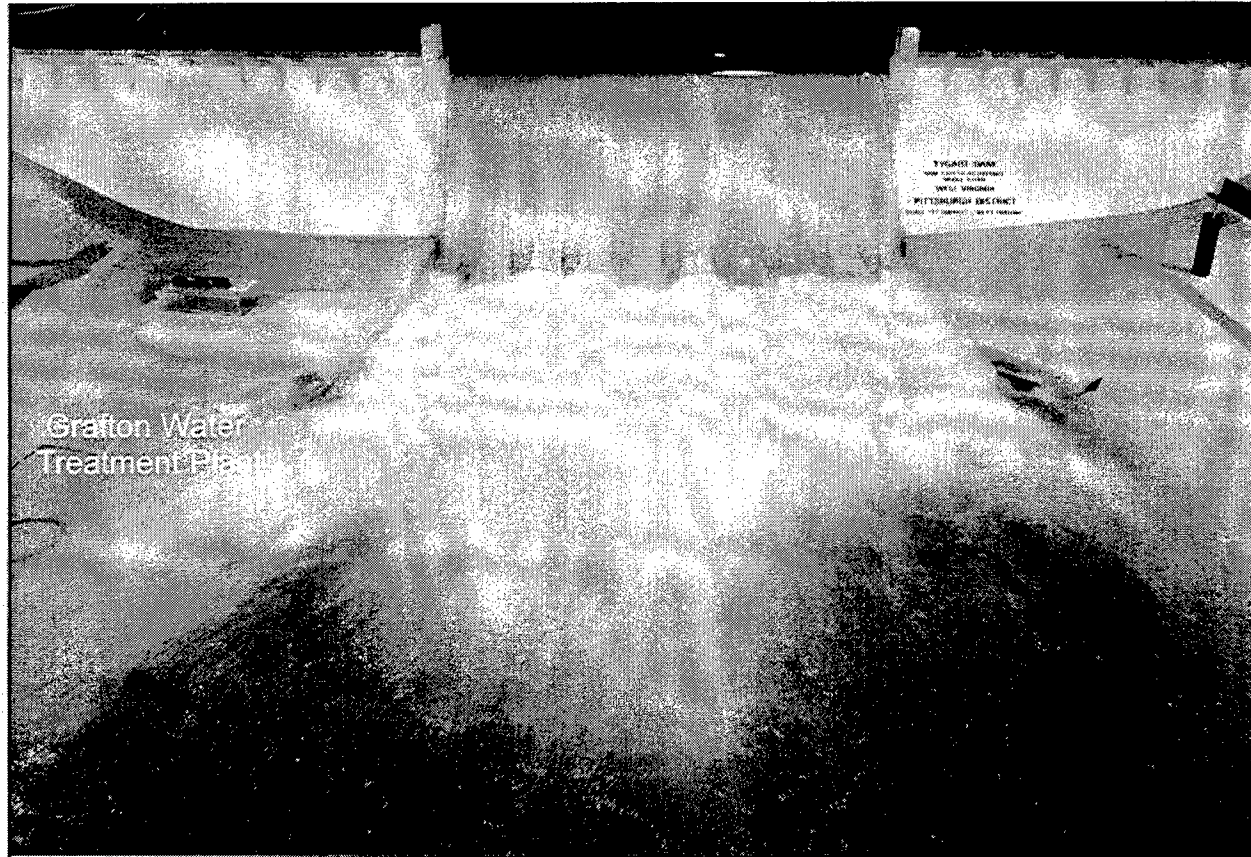
Photo 6. Tygart stilling basin flow conditions, spillway and sluice flow ( $Q = 250,780$  cfs;  
Pool = el 1190.0; TW el = 1020.0)

Photo 7. Tygart stilling basin flow conditions, spillway and sluice flow (Q = 250,780 cfs; Pool = el 1190.0; TW el = 1020.0)

Condition B flows are shown in Photos 6-7. The discharge for the Condition B flow was determined by gradually increasing the discharge from the Condition A flow until the stilling basin walls overtopped. As the discharge was increased, the tailwater was adjusted according to Plate 5. This flow was determined to be 7,102 cu m/sec (250,780 cfs) with a corresponding pool el of 1190. The tailwater in the downstream channel with this discharge is at el 1020. Condition B causes flooding near the channel (see Grafton Water Treatment Plant, Photo 7). With flow Condition B, the weir at the end of the stilling basin causes a forced hydraulic jump in the basin. A secondary jump also occurs in the channel downstream as the flow over the weir enters the tailwater.

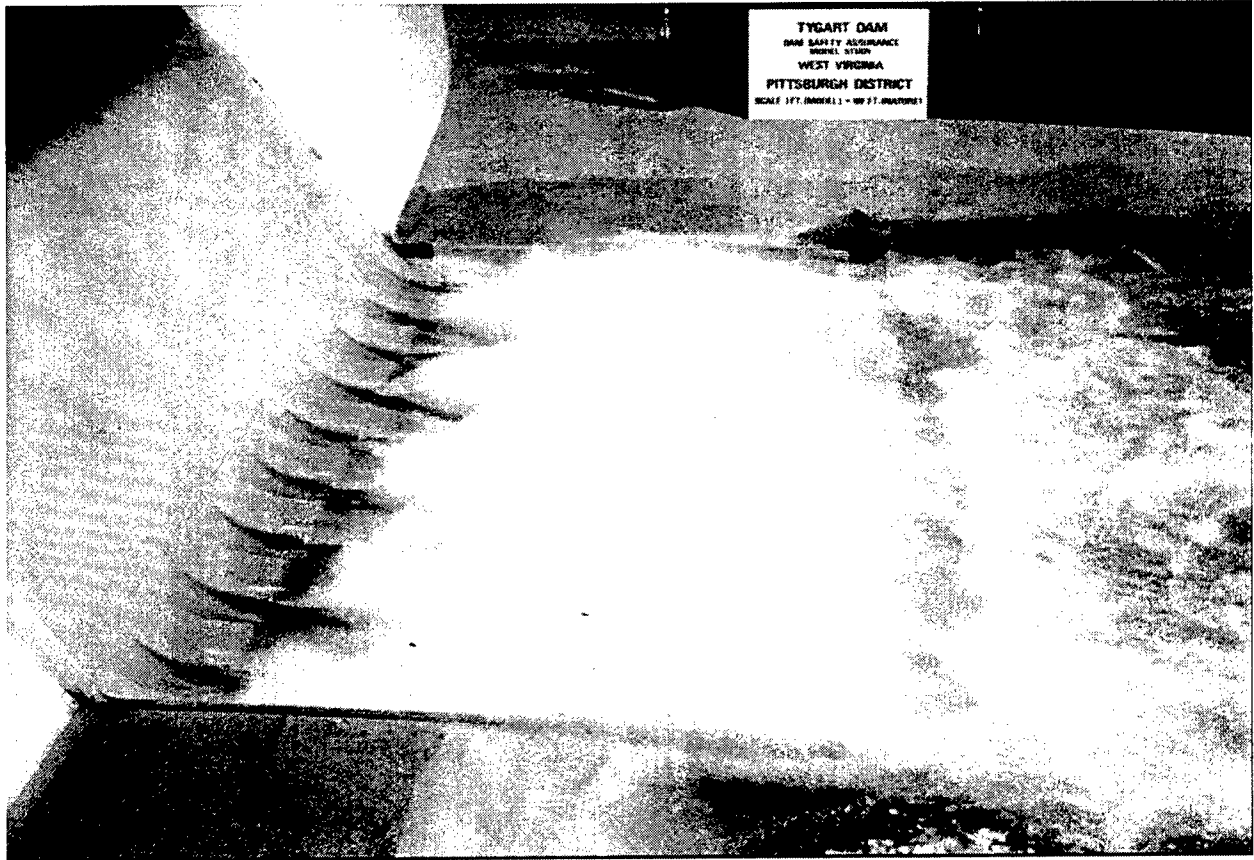
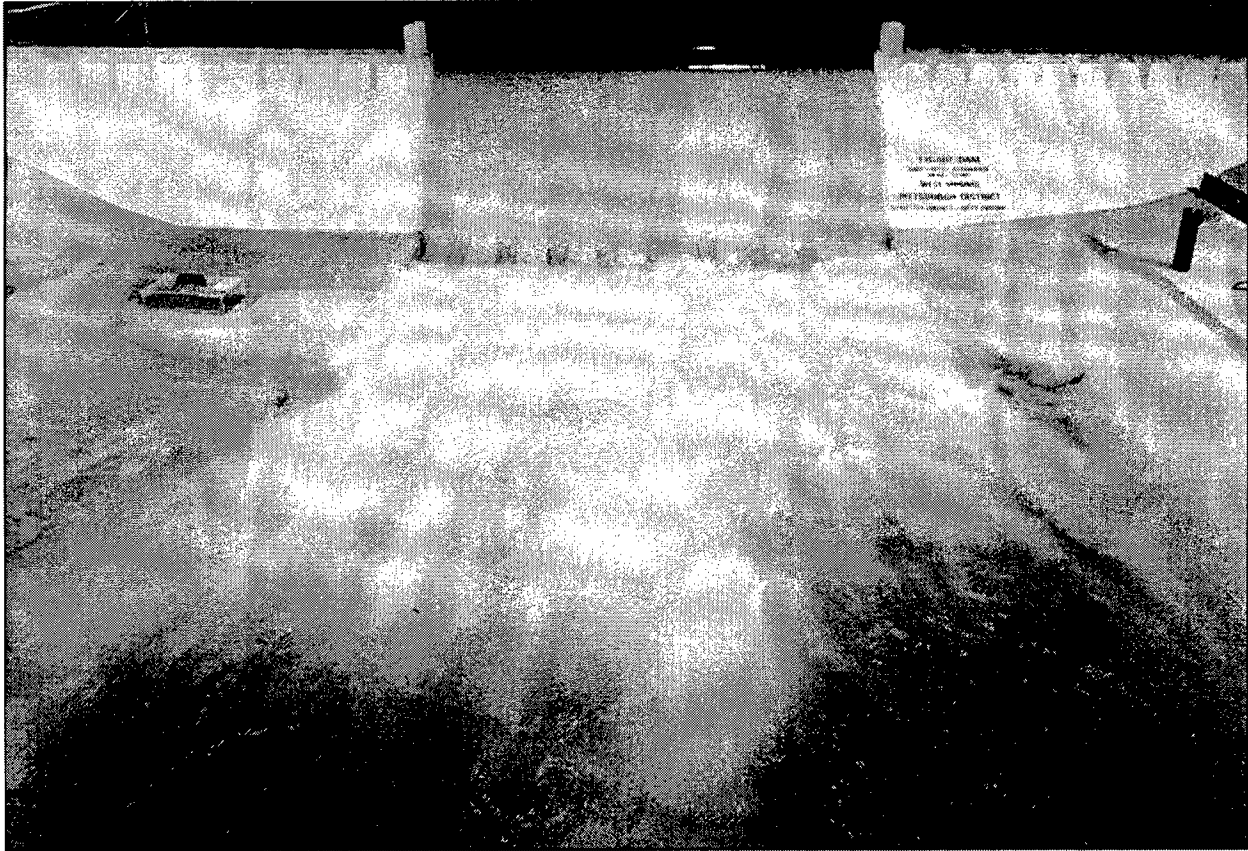
Photo 8. Tygart stilling basin flow conditions, spillway and sluice flow ( $Q = 319,080$  cfs;  
Pool = el 1194.25; TW el = 1026.5)

Photo 9. Tygart stilling basin flow conditions, spillway and sluice flow ( $Q = 319,080$  cfs;  
Pool = el 1194.25; TW el = 1026.5)

Photos 8-9 show conditions just before the pool elevation overtops the dam (Condition C). The discharge for Condition C was determined by gradually increasing the discharge until the pool elevation was the same as the top of the

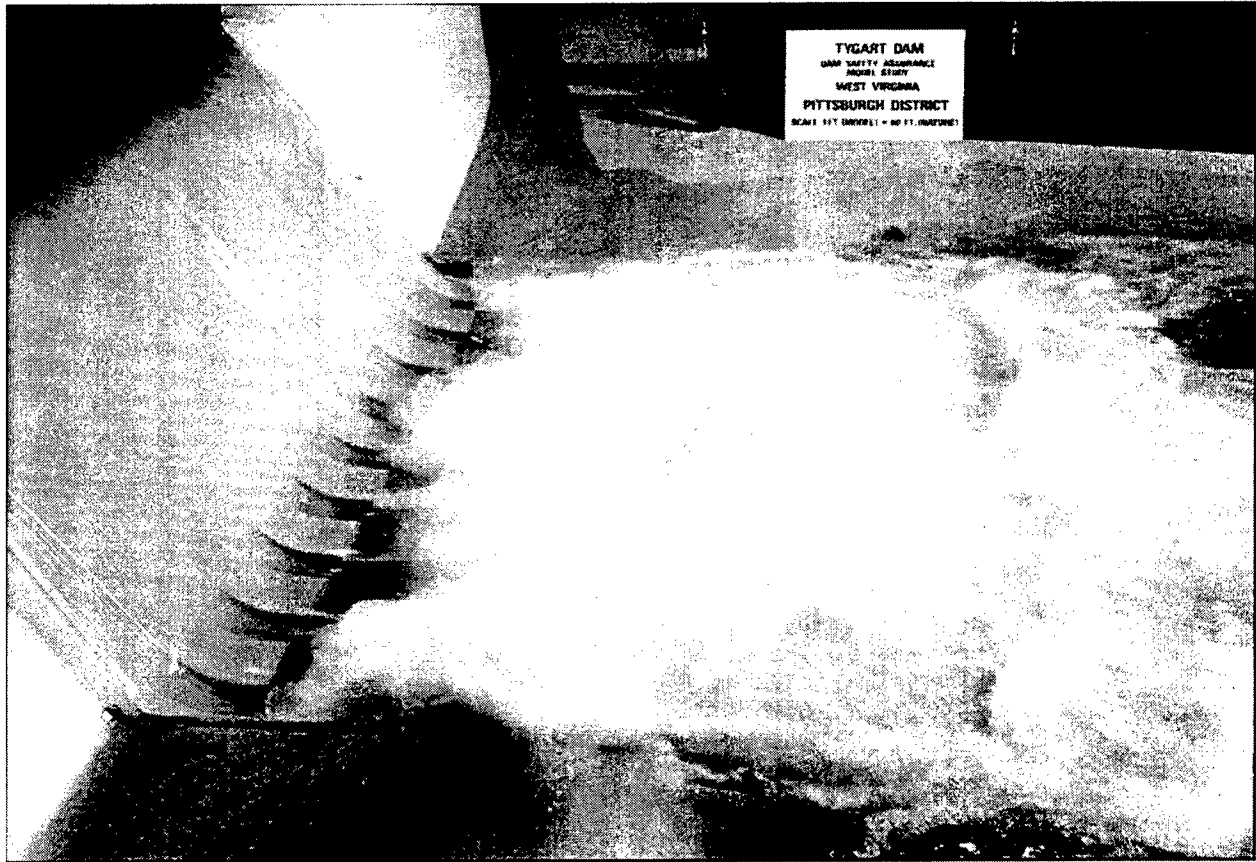
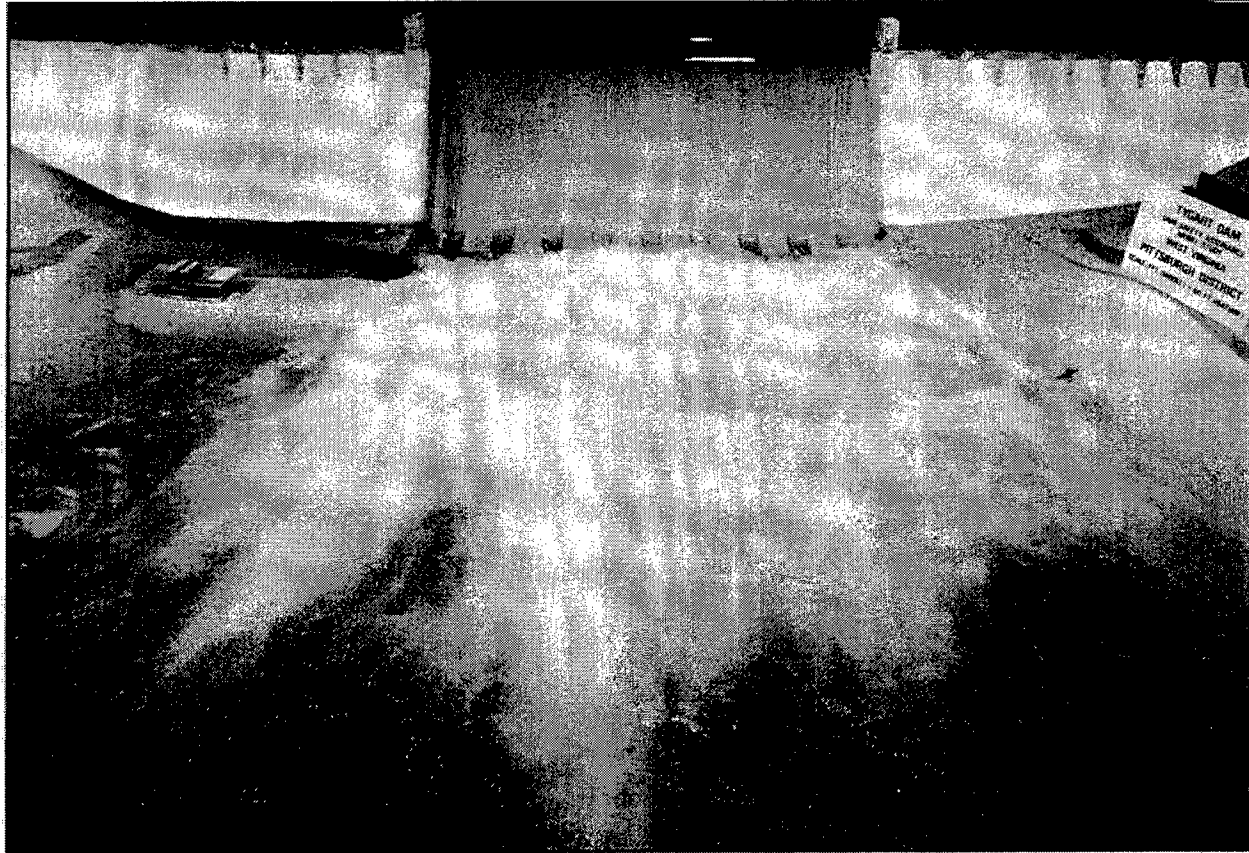
Photo 10. Tygart stilling basin flow conditions, PMF overtopping, spillway and sluice flow  
( $Q = 373,120$  cfs; Pool = el 1196.95; TW el = 1031.5)

Photo 11. Tygart stilling basin flow conditions, PMF overtopping, spillway and sluice flow  
( $Q = 373,120$  cfs; Pool = el 1196.95; TW el = 1031.5)

The PMF flow conditions, Condition D, are shown in Photos 10-11. At Condition D, the flow rate is 10,567 cu m/sec (373,120 cfs), the pool elevation is 1196.95, and the tailwater is at el 1031.5. The overtopping flow comes over the parapet walls and down the downstream face of the dam. Erosion of the natural terrain is expected to take place as the water impacts the ground surface and attempts to reenter the downstream channel. Some of the overtopping flow flanks the parapet wall on the right side and moves through the roadway opening. As shown in Photo 12, the flow is conveyed along the access roadway before spilling back down the terrain. On the left descending side of the dam, no flanking flow occurs because of higher terrain and the absence of an access roadway. The downstream flow conditions show that a forced hydraulic jump is still occurring in the stilling basin, the secondary jump has moved even farther downstream, and significant surface turbulence and wave action are associated with the secondary jump.

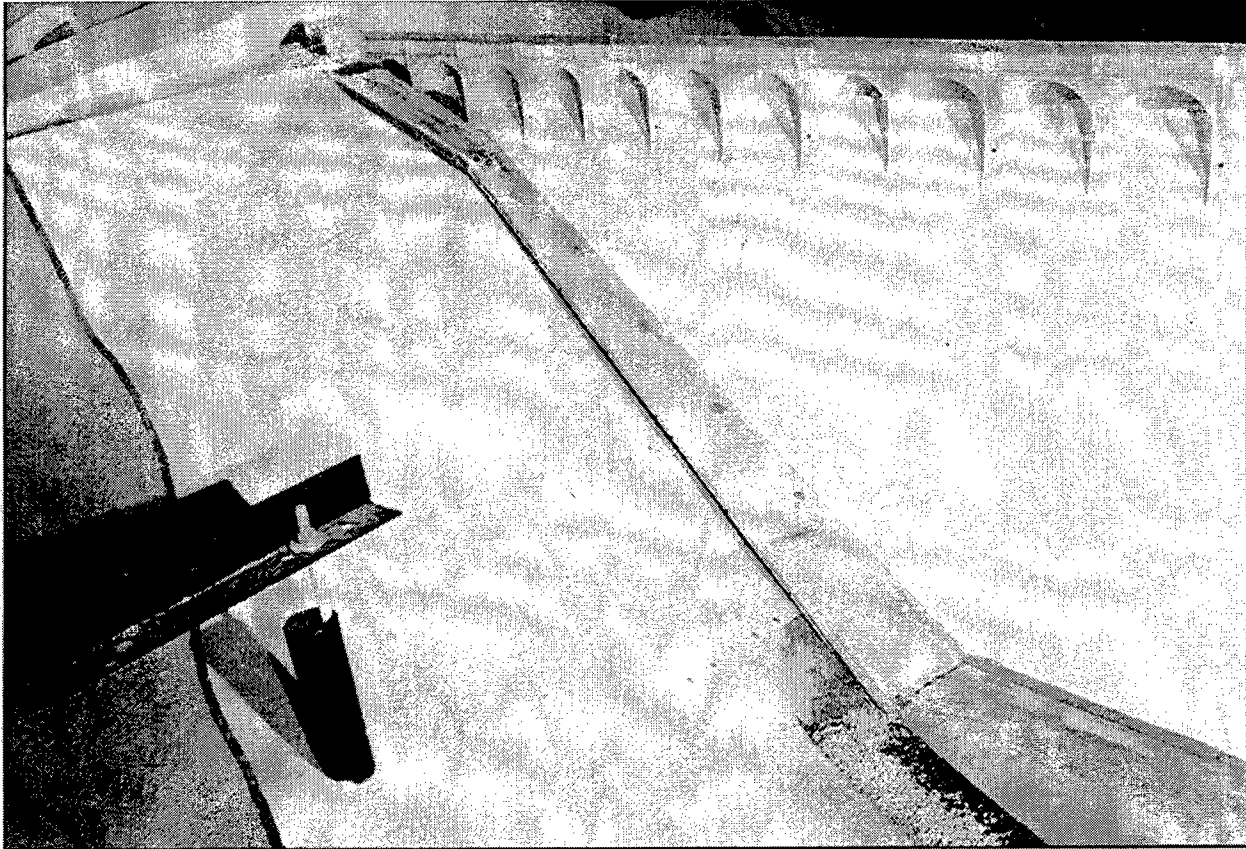
Photo 13. Type 2 design, gutter channel, dry bed, right side of dam

Photo 14. Type 2 design, apron and riprap, dry bed, right side of dam

The Type 2 design gutter channel is shown in Photos 13-14. Details of the Type 2 design are shown in Plate 10. At the top of the slope, the gutter is 6.1 m (20 ft) wide to allow for the roadway flow and to compensate for arch interference with the flow. At the toe of the slope, a paved apron was designed to allow the gutter flow to expand on the flat area. Riprap borders the apron and stilling basin to reduce erosion. Observations of the flow conditions with Condition D indicated that a barrier along the road was needed to prevent any flow from entering by the road.

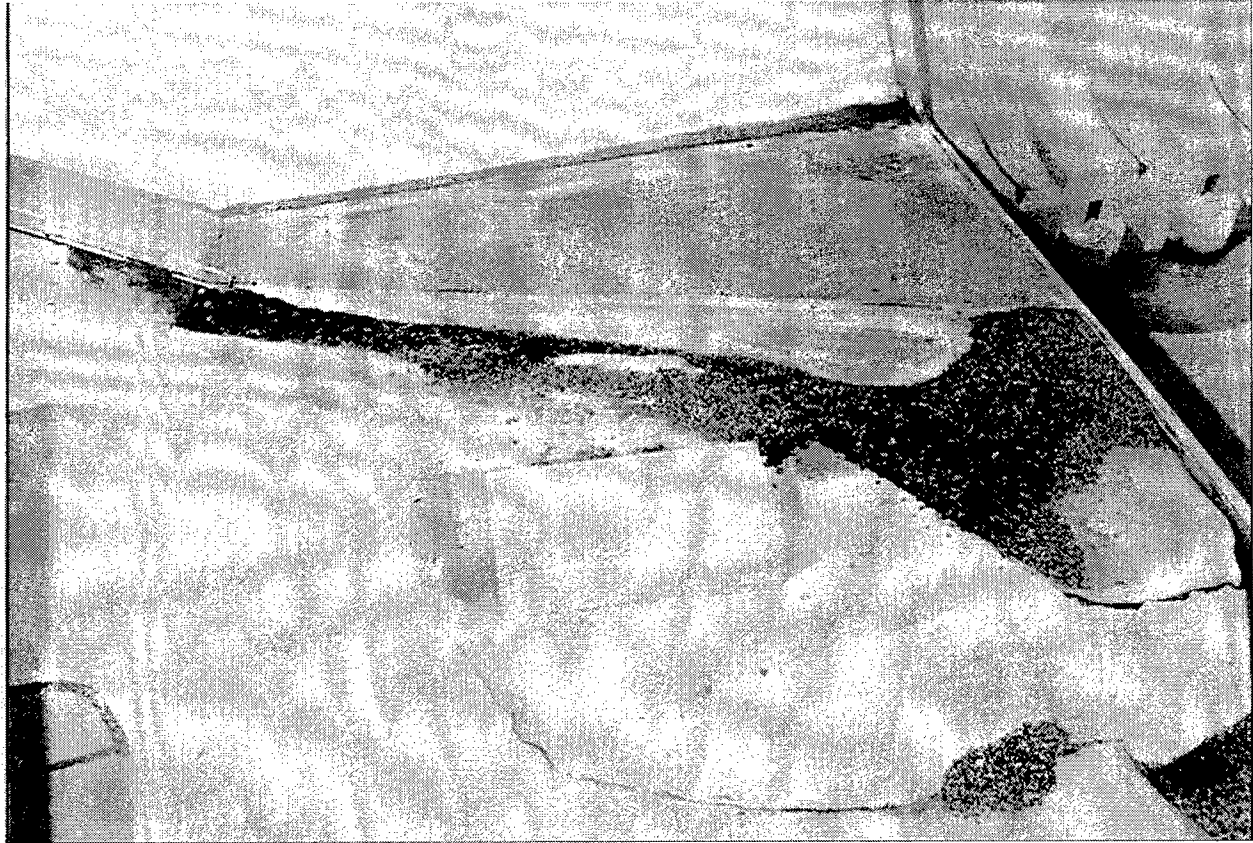
Photo 15. Type 2 design, damage resulting from PMF flow for 1 hr (proto), right side of dam

For performance and evaluation purposes, the modification was subjected to the PMF for a duration of 1 hr prototype (7.75 min model). Results of the Type 2 design, Photo 15, show that the flow upon leaving the confined gutter section expanded more than estimated and eroded the riprap protection. Failure of the downstream section of the riprap was caused by wave action from the stilling basin.

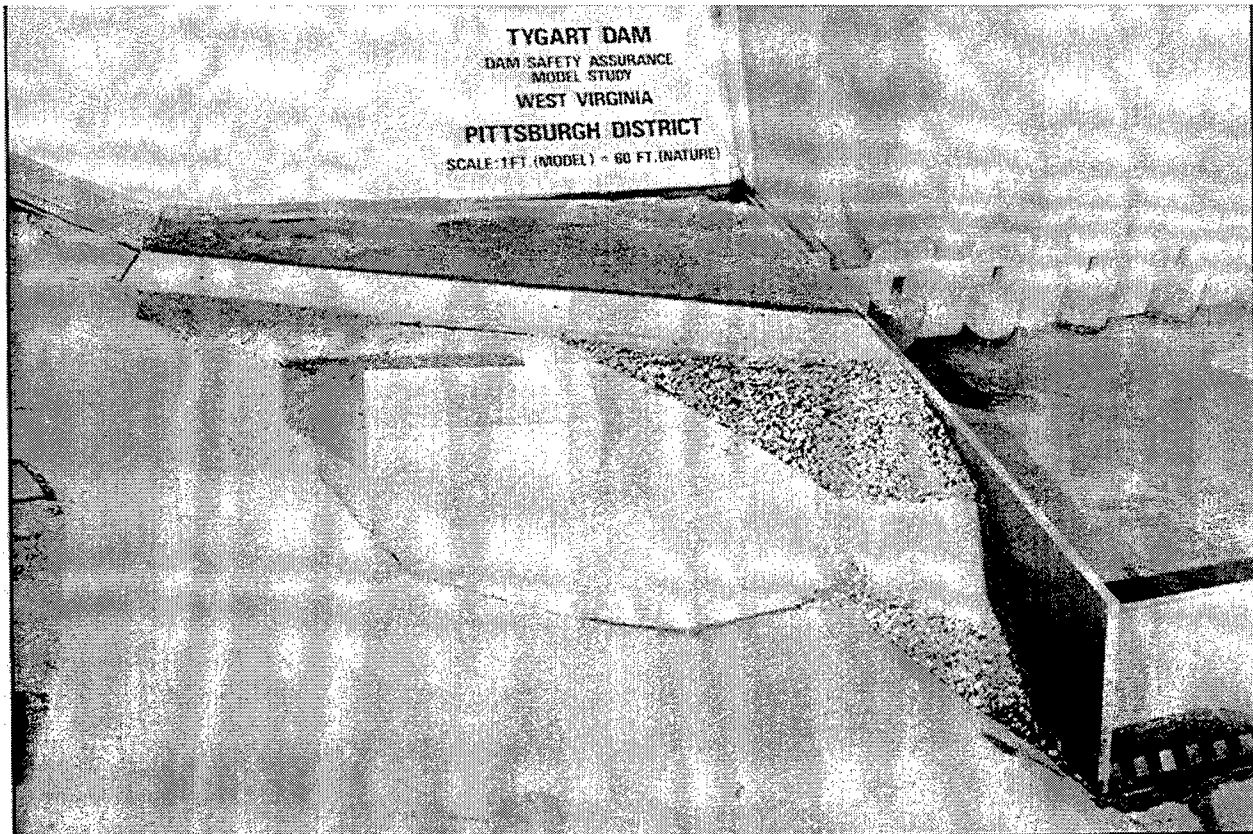
Photo 17. Type 3 design, damage resulting from PMF flow for 1 hr (proto), right side of dam

Because of failure of the riprap with the Type 2 design, the Type 3 design, Photo 16, was developed. This design expanded the concrete apron 30 ft and used larger riprap. Dimensions of the Type 3 design are shown in Plate 11. After subjecting the design to the PMF for 1 hr prototype (7.75 min model), damage because of flow expanding from the gutter and stilling basin wave action was still present, as shown in Photo 17.

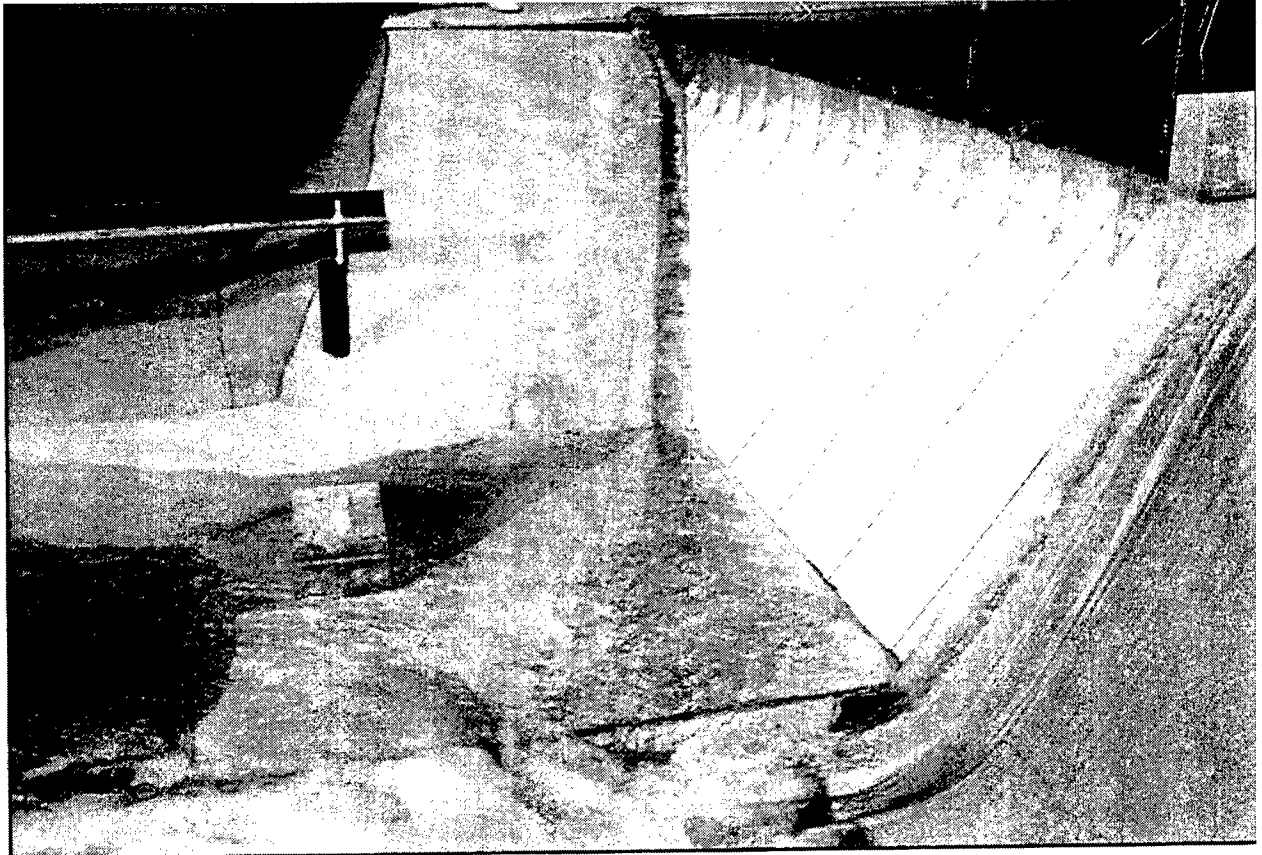
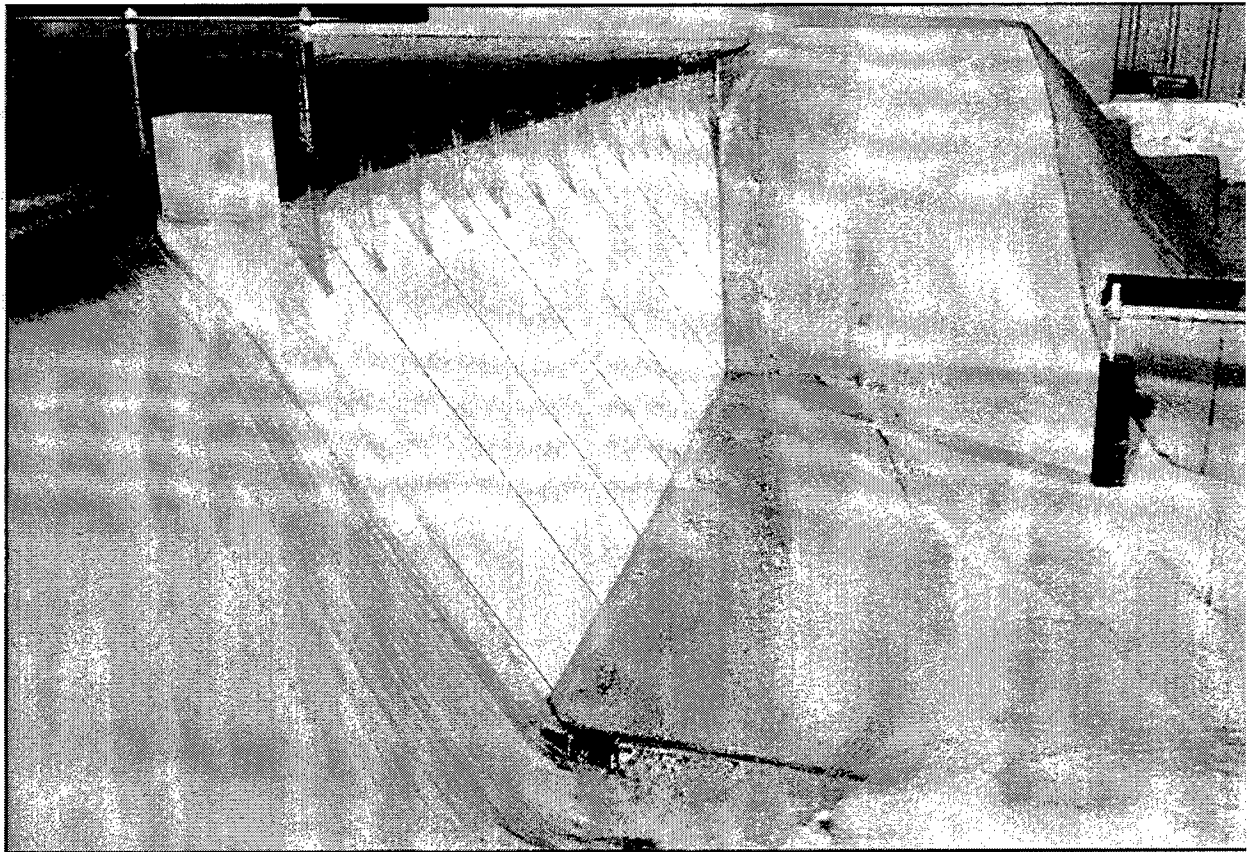
Photo 18. Type 4 design, PMF overflow on right side of dam ( $Q = 373,120$  cfs; Pool = el 1196.95; TW el = 1031.5)

Photo 19. Type 4 design, PMF overflow on left side of dam( $Q = 373,120$  cfs; Pool = el 1196.95; TW el = 1031.5)

Flow conditions for the PMF are shown in Photos 18-19. In Photos 18-19, dye was added to the gutter flow to observe the flow from the gutter on the apron. Maximum depths in the right gutter channel are shown in Plate 14. Velocities, shown in Plate 15, were measured to show the magnitude and location of velocities on the concrete apron during PMF flow conditions. These velocities were measured approximately 1 ft above the ground surface.

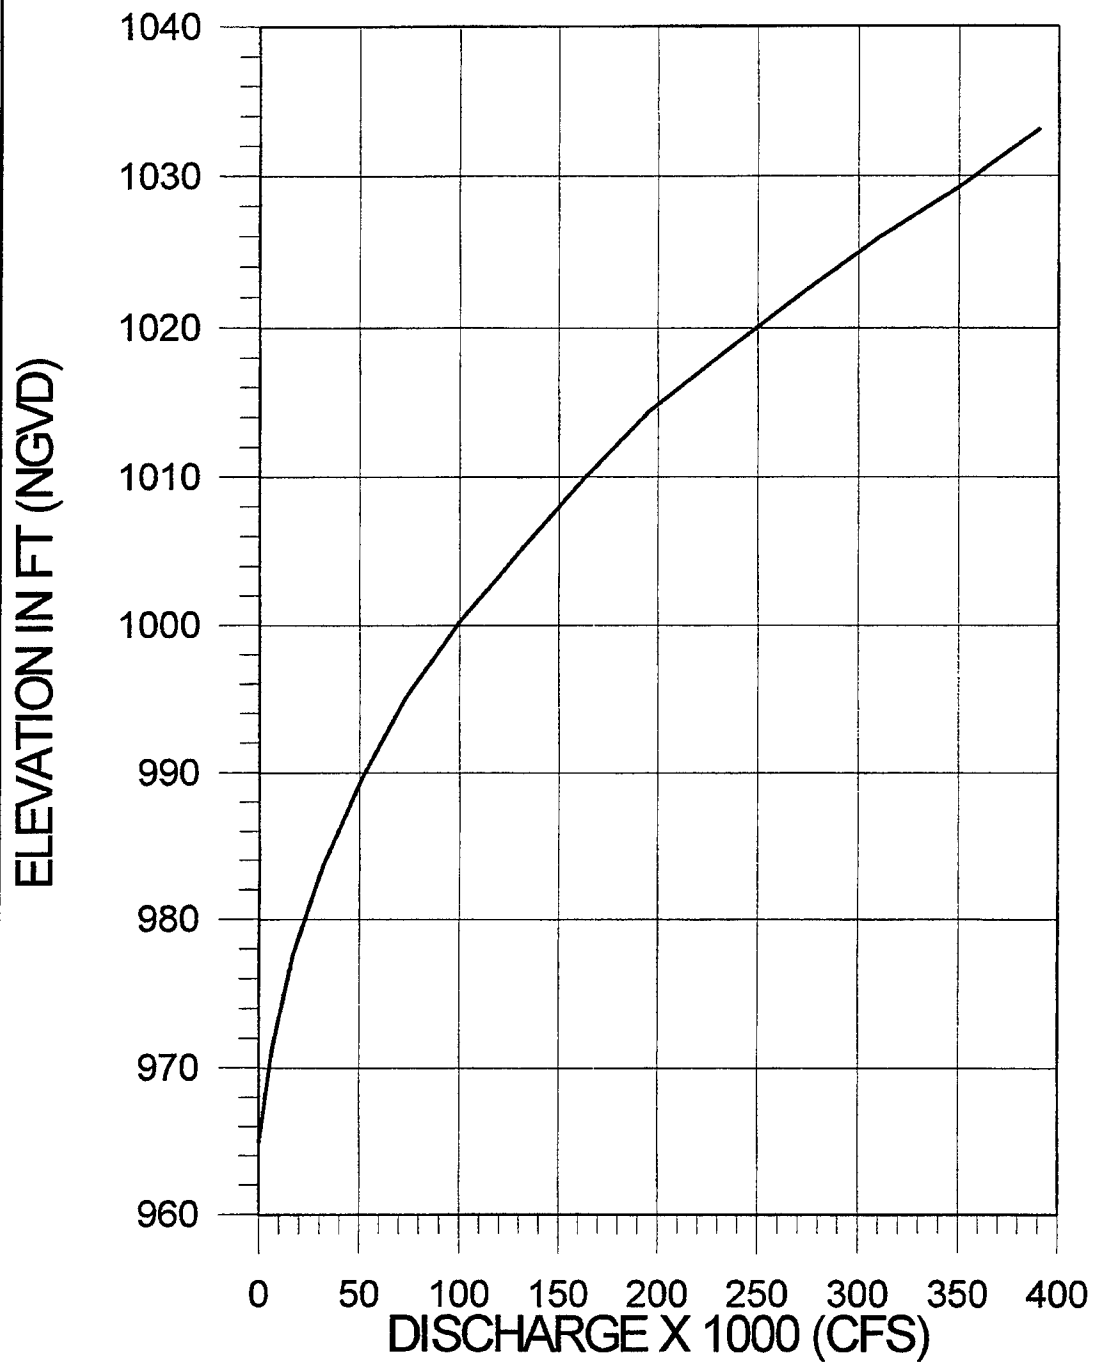
TYGART DAM  
STAGE - DISCHARGE CURVE  
1100 FT D/S OF STILLING WEIR

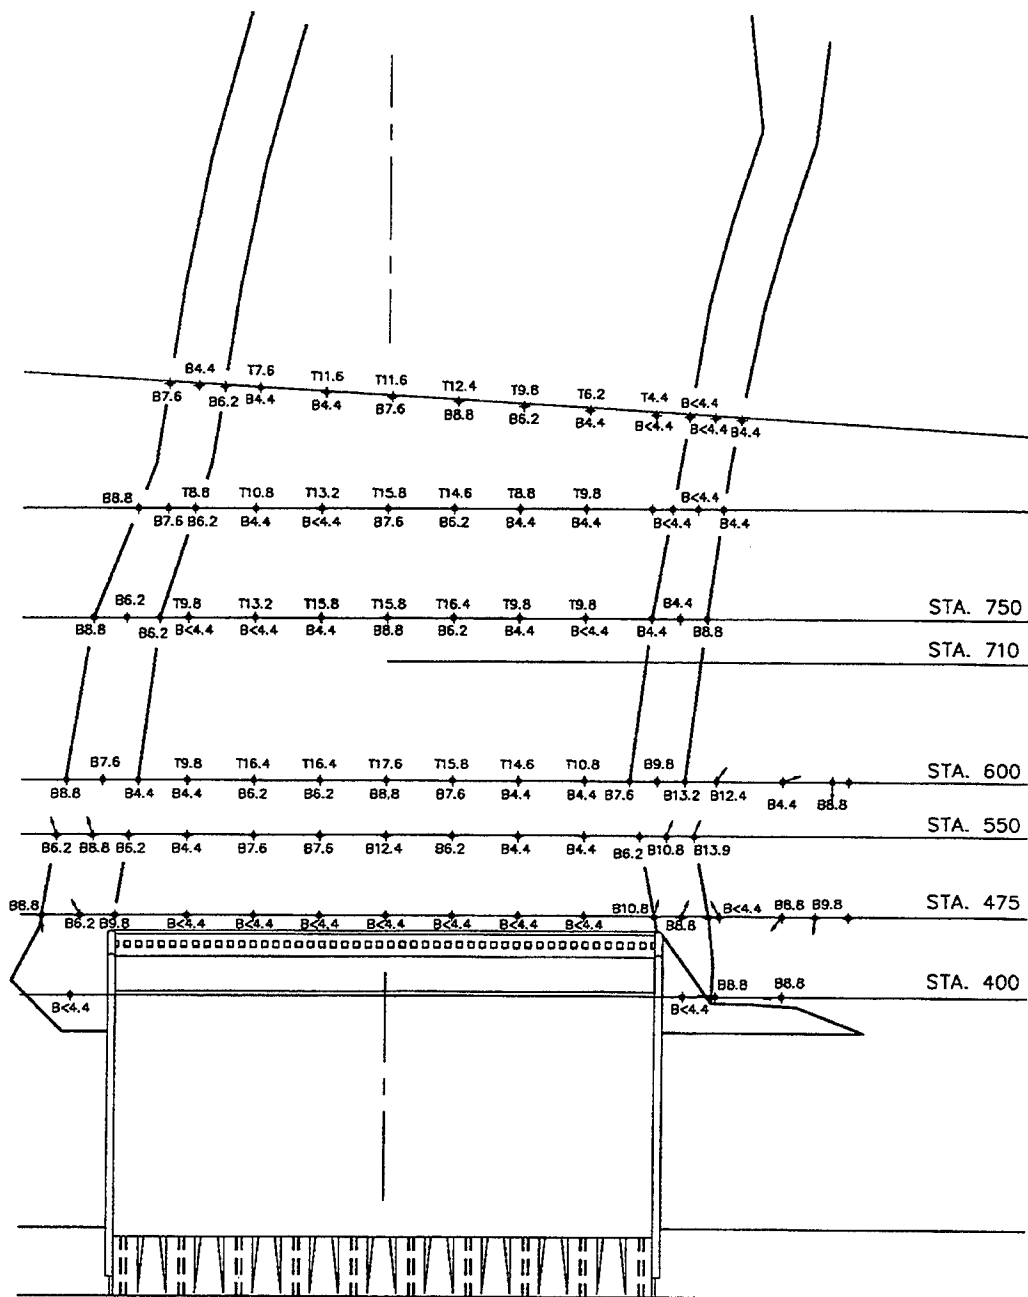
**DOWNSTREAM VELOCITIES  
TYPE 1 DESIGN  
CONDITION B**

VELOCITY UNITS: FT/SEC  
T - 2 FT BELOW SURFACE  
B - 2 FT ABOVE BOTTOM

Downstream velocities for flow conditions A, B, C, and D are shown as Plates 6-9. Average bottom velocities just downstream from the weir ranged from 4.9 ft/sec on the left side of the channel to 12.9 ft/sec just to the right of the channel center line. Surface velocities were much lower and better distributed (ranged from 2.5 to 3.1 ft/sec). Farther down the channel, the flow velocities were higher in the center of the channel, and the surface velocities were higher than the bottom velocities.

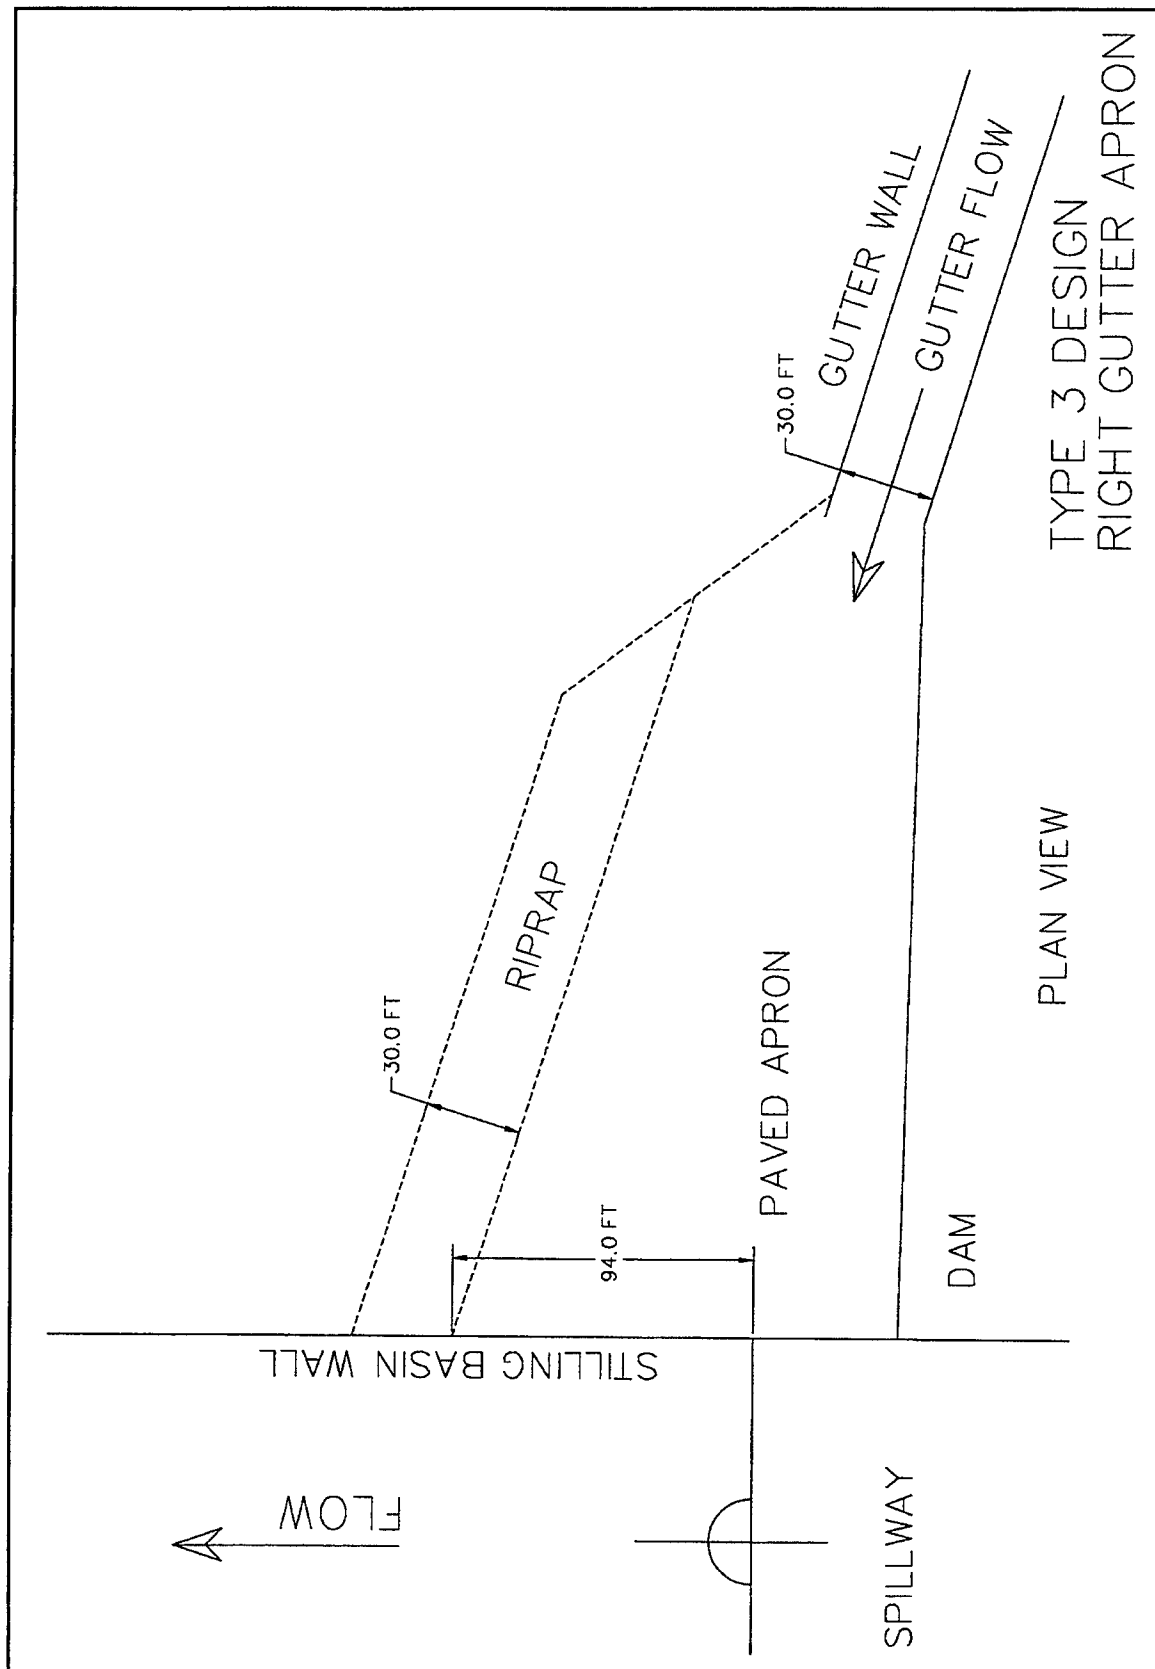
TYPE 3 DESIGN  
 RIGHT GUTTER APRON

PLAN VIEW
